## Application Note AN M152

# FTIR Microscopy in Automotive Industries: Large Sample Analysis

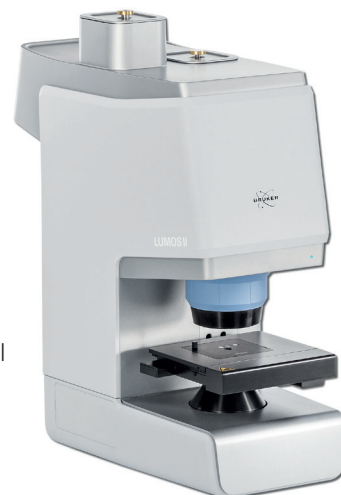
The LUMOS II is a sturdy FTIR microscope that is self-explanatory in its workflow.

It offers an excellent optical inspection of microscopic samples and yields valuable chemical information as well. For inexperienced users it offers a helpful software assistant that guides the
